MSC-07684

APOLLO 16 MISSION

ANOMALY REPORT NO. 9

LUNAR ROVING VEHICLE ELECTRICAL SYSTEM
METER ANOMALIES

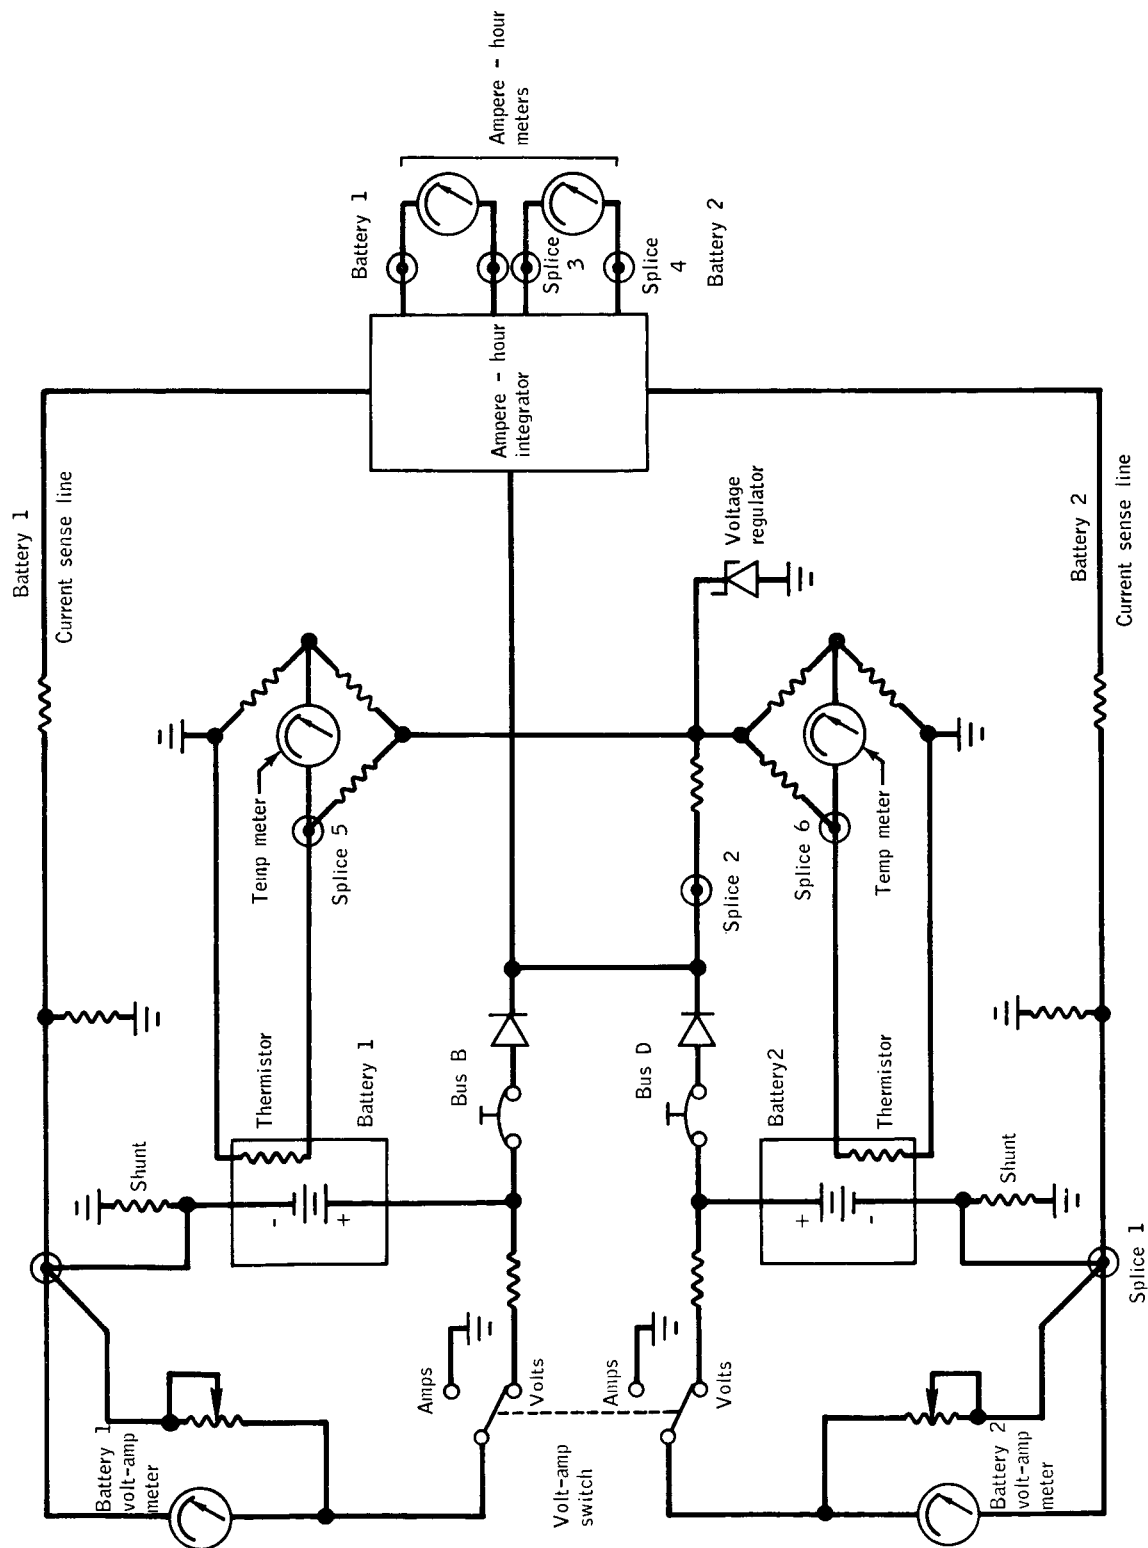
Figure 1.- Lunar roving vehicle electrical meters circuitry.

No single condition was found which would explain all anomalous meter indications. However, intermittent connections in some of the multiple wire crimp splices shown in figure 1 could explain the meter readings.

An intermittent connection in splice 1 could cause the battery 2 voltmeter to read off-scale low. Also, an intermittent connection in splice 3 or 4 would cause the battery 2 ampere-hour meter to read off-scale low. To cause both temperature meters to read off-scale low would require intermittents in either splice 2 or in both splices 5 and 6. An intermittent in splice 1 would cause the ampere-hour integrator 1 to indicate increasing rather than decreasing ampere-hours remaining, since the polarity on the current sense line would be reversed as shown in figure 2. Finally, an intermittent connection in splice 5 would cause the battery 1 temperature meter to indicate off-scale low.

Intermittent conditions must have existed in several of the multiple wire splices shown in figure 1.

No corrective action could be taken since the cause of the intermittents was not determined.
